**SHORELINE CHANGE ANALYSIS OF VIZHINJAM COAST USING  
BEACH PROFILES AND SATELLITE IMAGES**

**ANNUAL REPORT  
(October 2018 to September 2019)**

**ADANI VIZHINJAM PORT PVT LIMITED**

**Coastal and Environmental Engineering Division  
NATIONAL INSTITUTE OF OCEAN TECHNOLOGY  
CHENNAI  
DECEMBER, 2019**

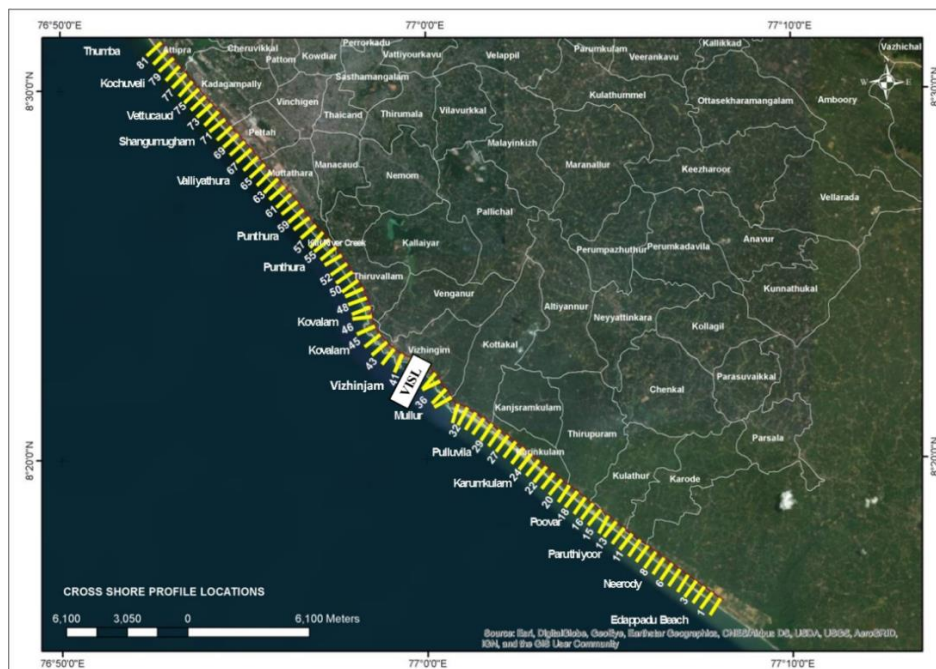
**Figure 3.4 Beach Profiles lines**

Shoreline Change analysis using Cross shore Profile (CSP) has been done as part of the Shoreline Monitoring Programme. CSP data is being collected monthly by the surveying agency every month at 81 profile lines along a stretch of 40 km covering the area of approximately 20 km south and 20 km north of the proposed Vizhinjam port (Since February 2015 to till date). The locations of the CSP lines are shown in Figure 3.4, and the corresponding landmarks and location names are given in Table 3.3. However, due to rough sea condition along the Vizhinjam coast, offshore profiles for the months from June 2019 to August 2019 have not been collected. The offshore profiles collected for the month of September 2019 has been considered for the overall beach volume change analysis.
