Vizhinjam International Seaport Limited

Sub: Vizhinjam International Deepwater Multipurpose Seaport - Environmental Clearance – Half yearly Compliance report

The compliance report of conditions stipulated in the cited references for the half yearly period from October 2015 to March 2016 is enclosed herewith, in both hard and soft copy for records and reference.

Report on Oceanographic & Bathymetric Data Collection for Assessment
of Shoreline Changes at Vizhinjam
Ocean Science Report No.: OSaS/P18115/VISL/Monsoon/104 Rev

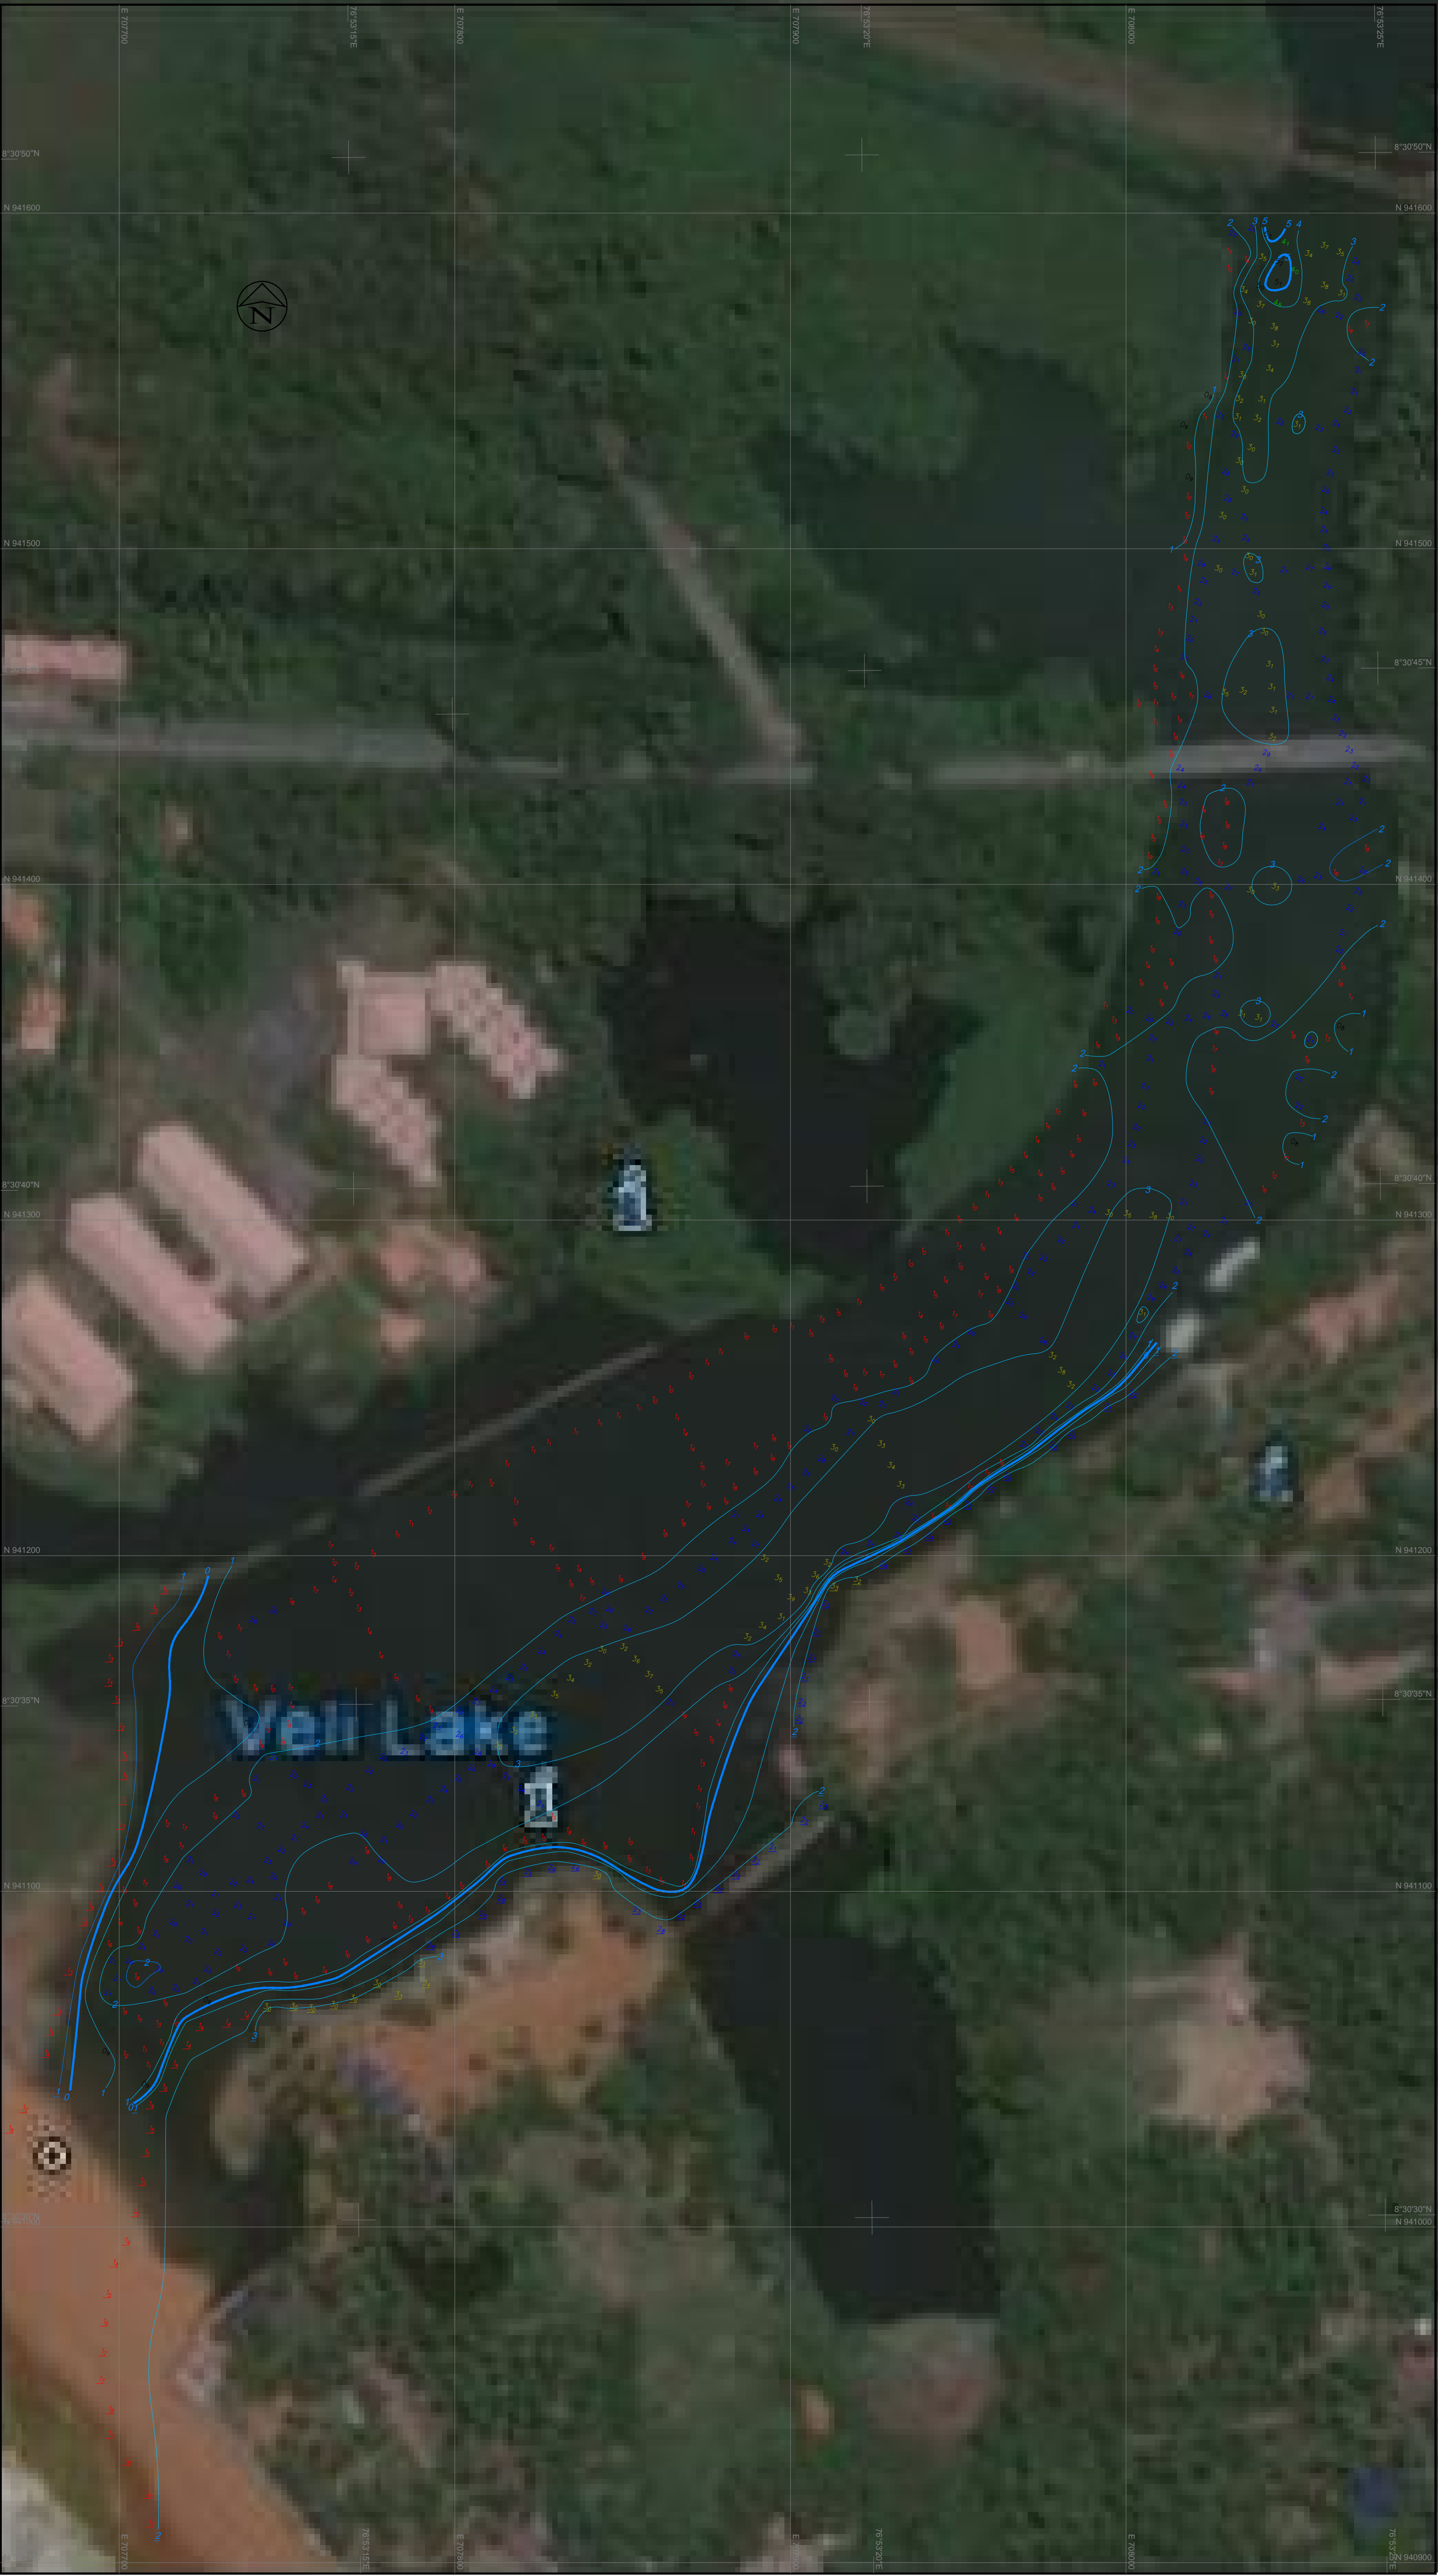
Drawn : U.M. Kadam Interpreted : Hebin C / S. Behara Approved : S. Philip
Dwg. No. : OS&S_P18115_VISL_BATHY_01

- Background details shown in the chart are extracted from google earth image.
- Tide is not applied to the raw depth.
The depth given is the actual observed water level from surface.
