Vizhinjam International Seaport Limited

Sub: Half Yearly Compliance Report (HYCR) of Environmental and CRZ Clearance for Vizhinjam International Multipurpose Deepwater Seaport for the period **April 2021 to September 2021** – reg.

Development of Vizhinjam International Deepwater Multipurpose Seaport

Half Yearly Compliance Report (HYCR) on Conditions Stipulated in Environmental & CRZ Clearance (EC) F.No.11-122/2011-IA.III dated 03.01.2014 for the Period April 2021 to September 2021

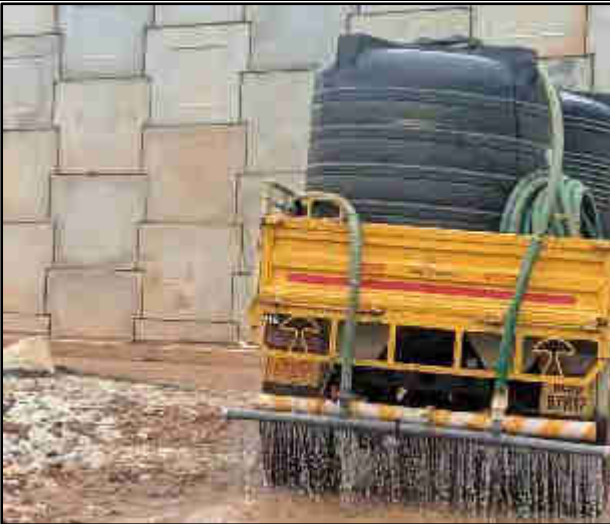
<p>Water Sprinkling in Progress</p>

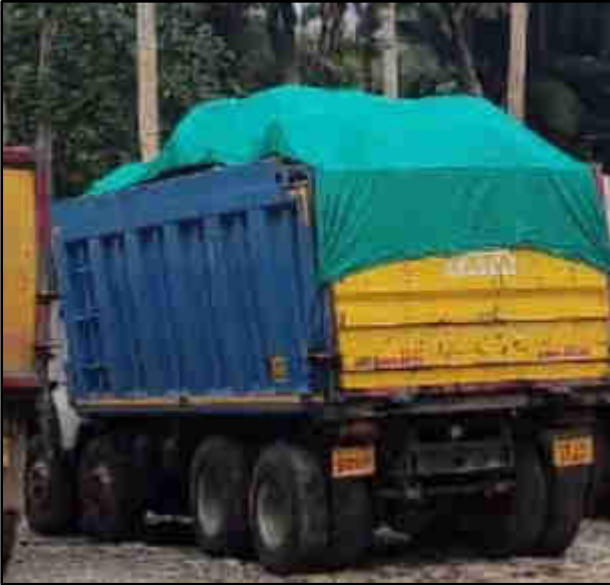
<p>Tarpaulin Cover on Trucks</p>

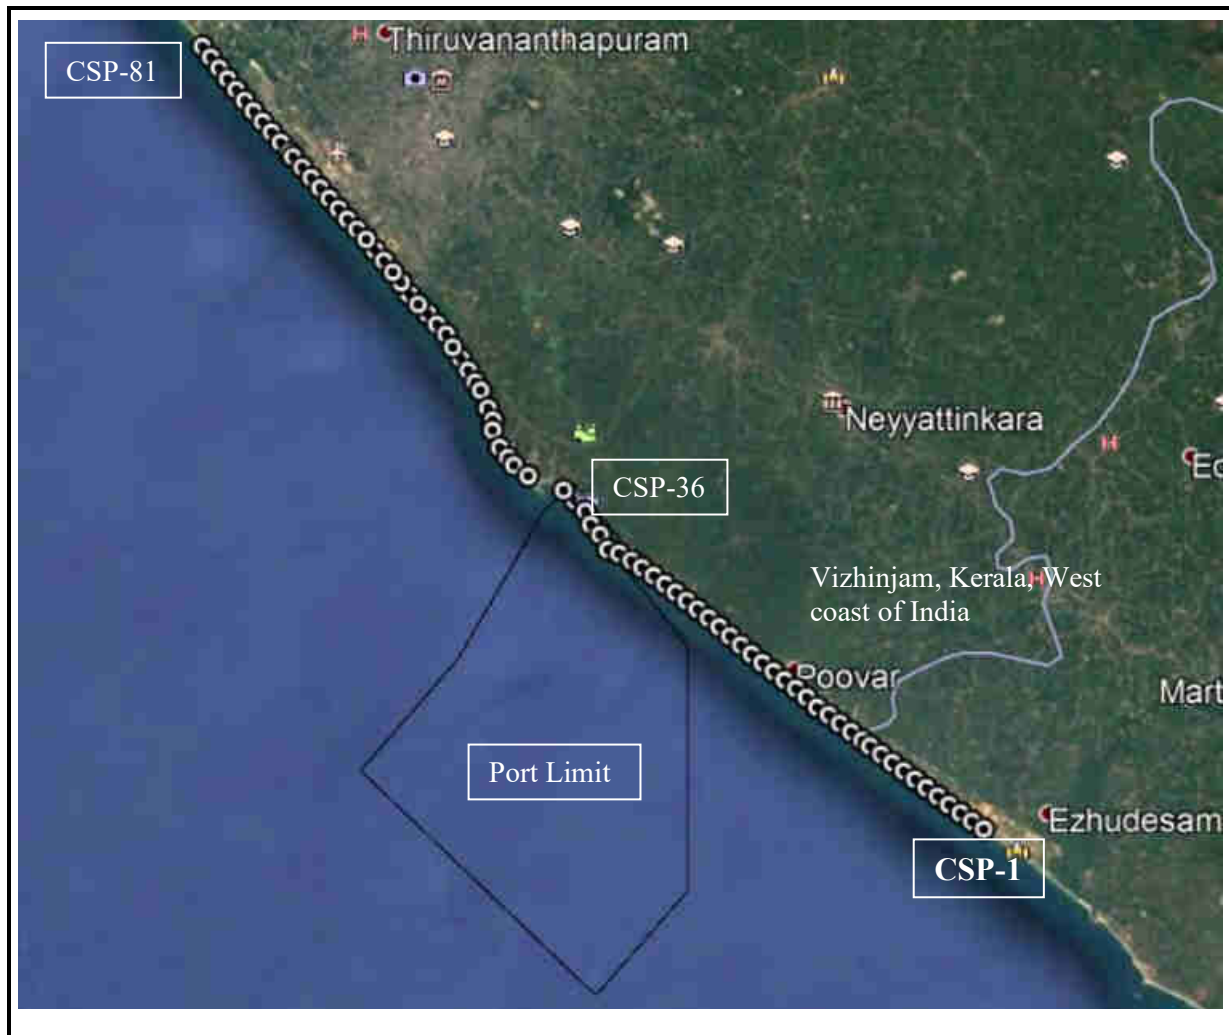
Figure 2-3: CSP, LEO and Photographic Documentation Locations

The CSP lines, which coincide with the Littoral Environment Observation (LEO), beach sampling and photographic documentation, are indicated in Figure 2-3. The cross-shore profiles are named as CSP-01 to CSP-81. CSP-01 corresponds to the southernmost profile which lies to the south of the existing Vizhinjam Harbour and gradually increases progressing towards north for the entire 40 km stretch (20 km on either side of the port) with a 500 m interval between each CSP line, CSP-81 being the northernmost profile.

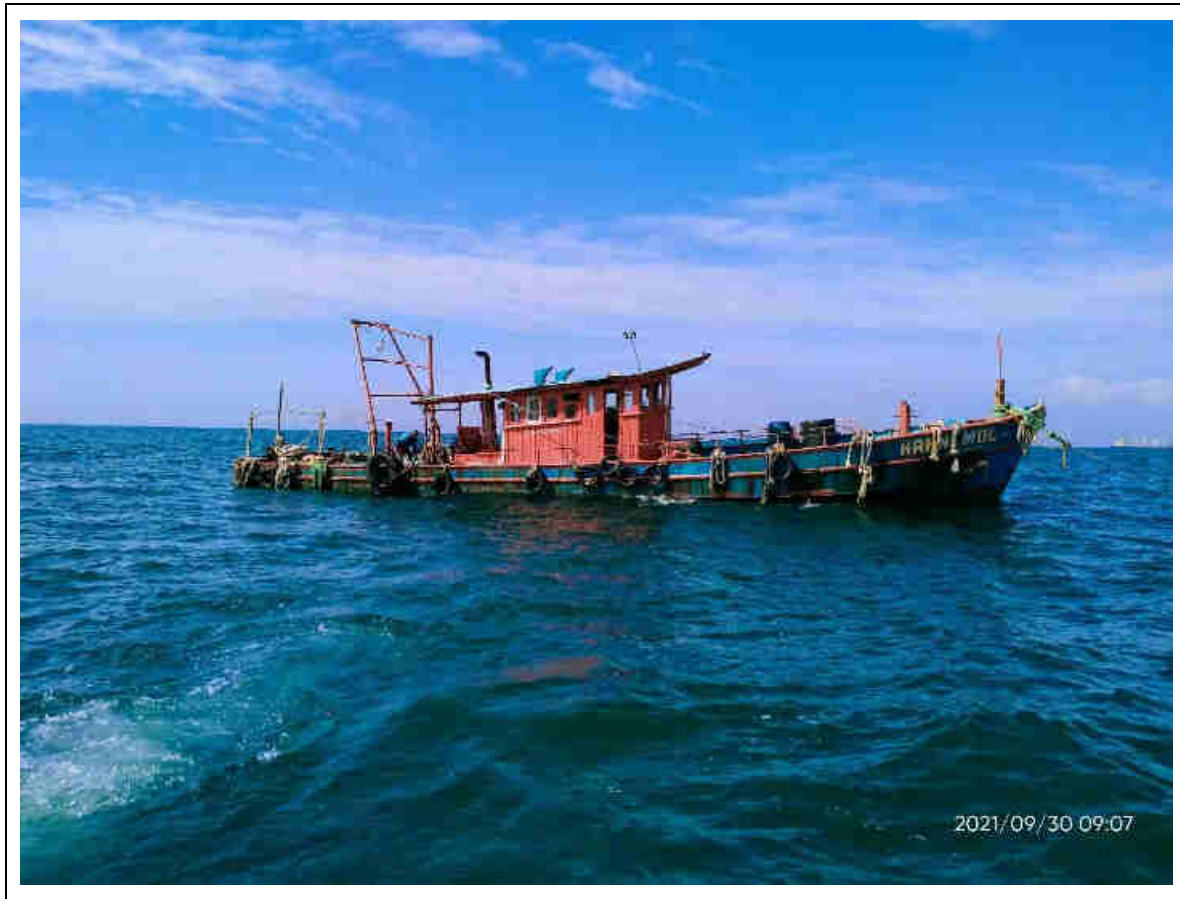
Figure 4-1: Watch keeping vessel MFB Hannemol

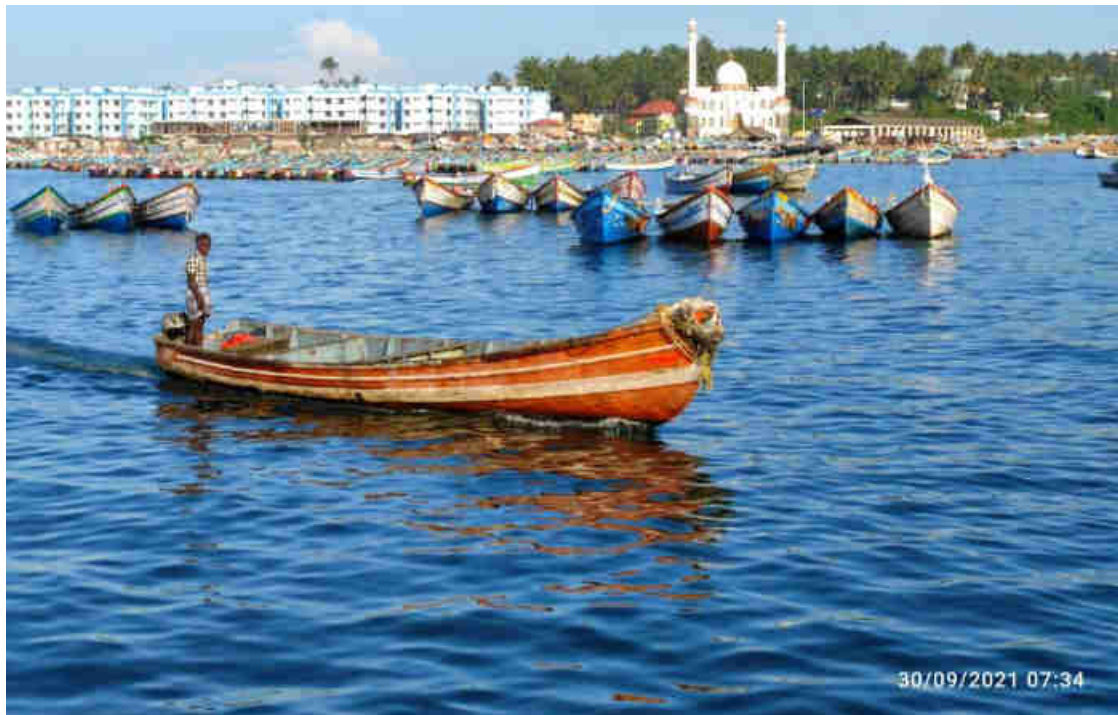
Figure 4-2: Transit vessel MFB Sindhu Yatra Matha

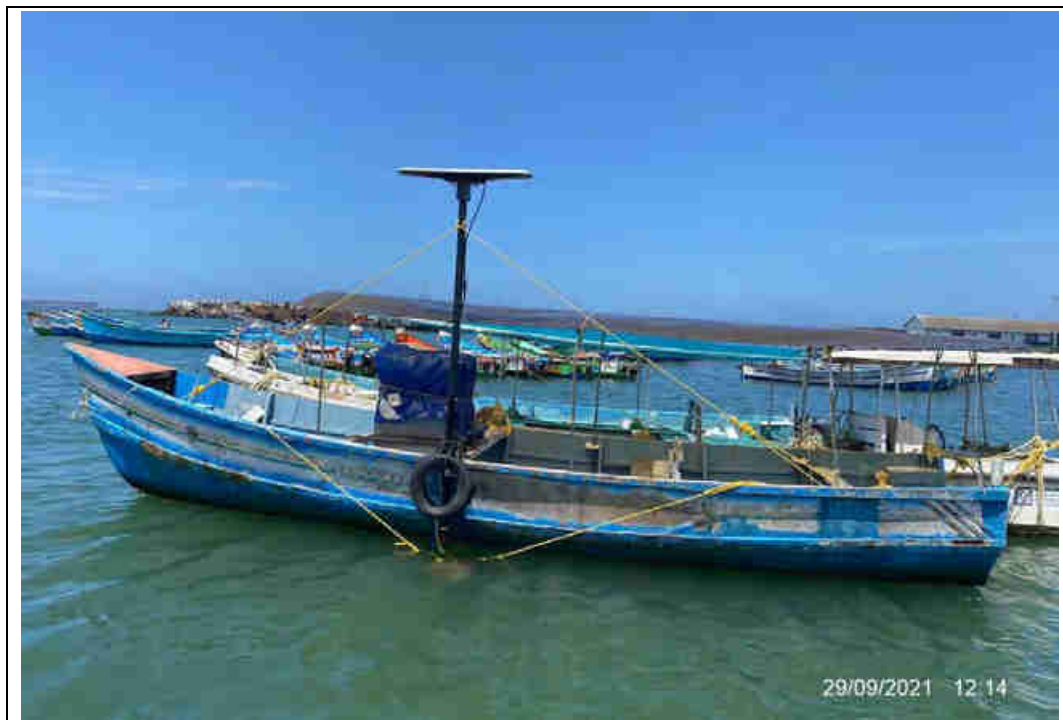
Figure 4-3: Multibeam Survey boat MFB Bethel

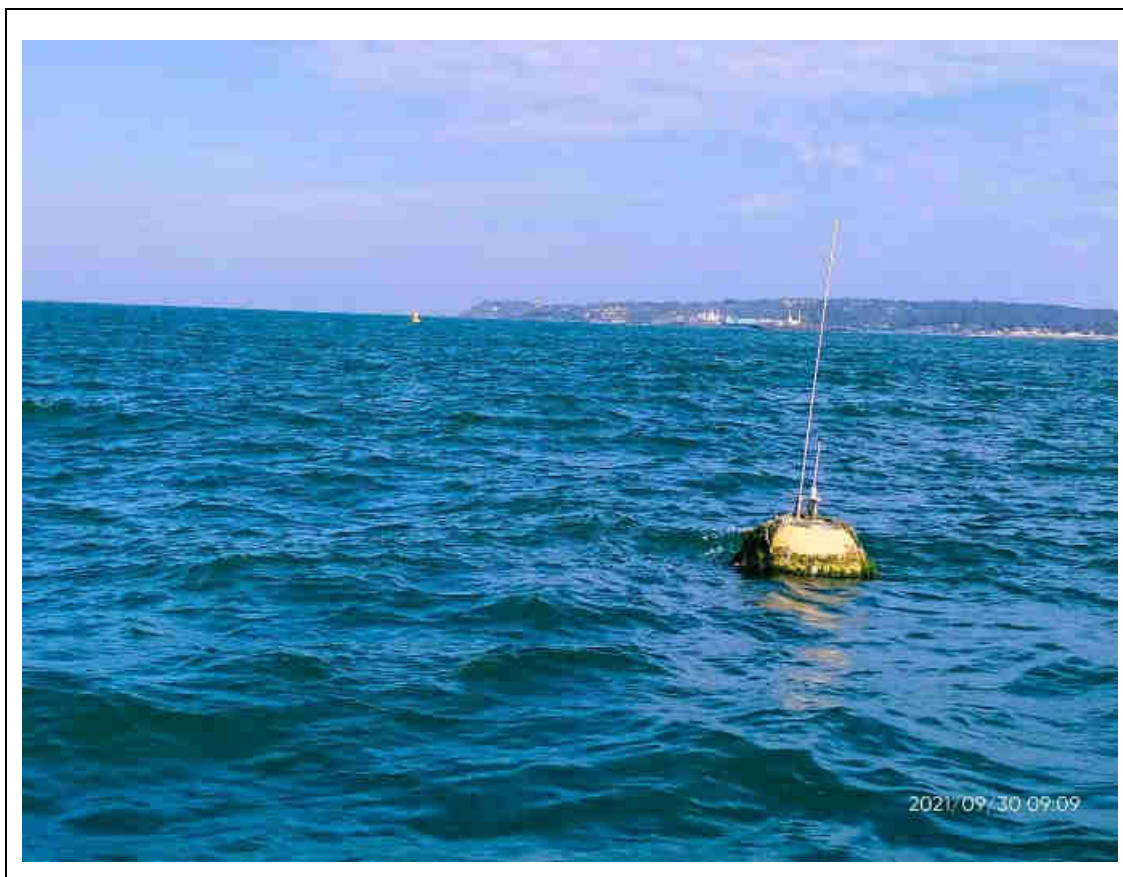
Figure 5-2: WRB deployed at site

A photograph of WRB deployed at the location is shown below:

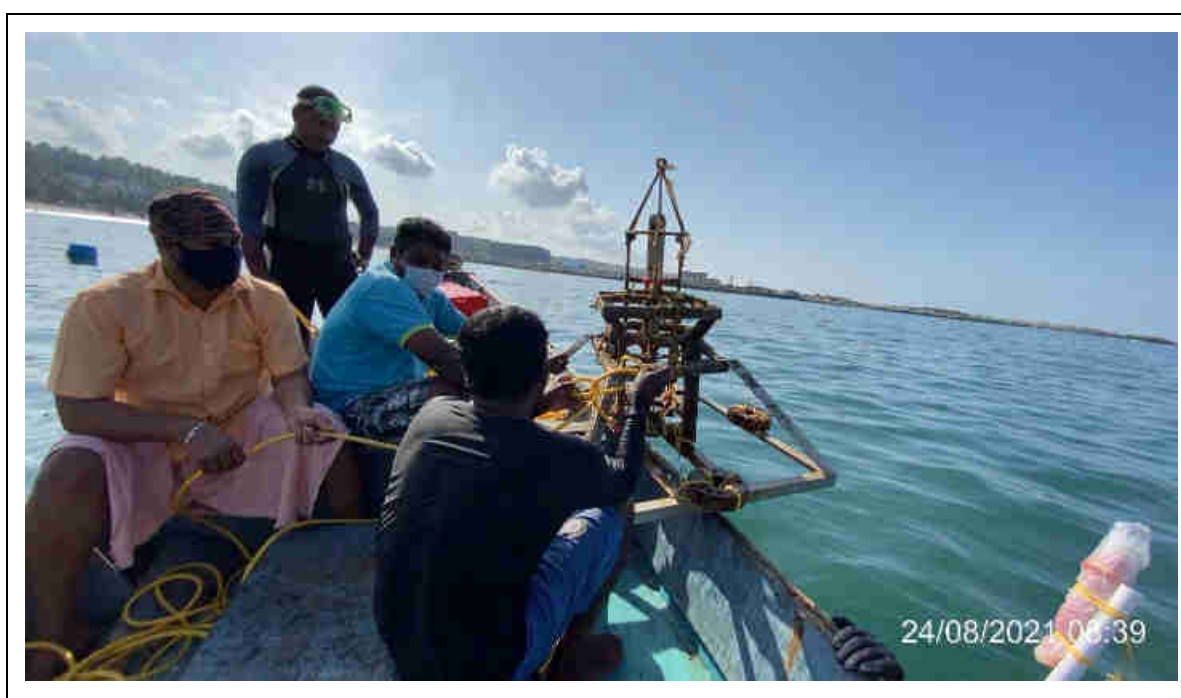
Teledyne Workhorse Sentinel 600 KHz Acoustic Doppler Current Profilers (ADCP) and Nortek Aquadopp 600 KHz ADCP's were installed at locations P1, P2, P3 and P4, namely, Vizhinjam, Poovar, Pachalloor and Mulloor for different seasons. The current speed and direction were measured at intervals of every 10 minutes from surface to seabed at every 1m bin. Data from three various depths i.e. at the surface, mid-depth and bottom at each location are provided in the report. The following figure shows the ADCP installation in an upward looking mode.

Figure 5-3: ADCP deployment at Vizhinjam

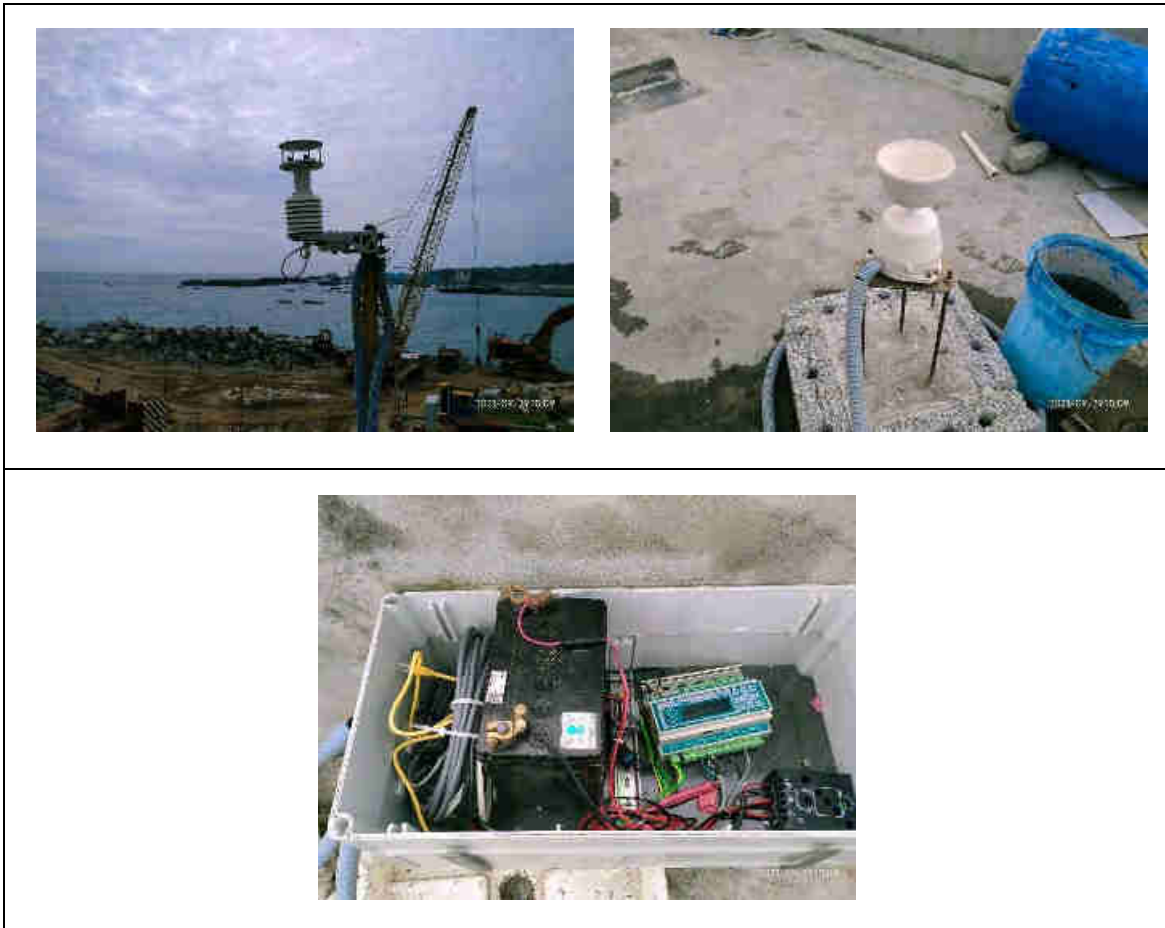
Figure 5-5: AWS on top of Port Control Office building

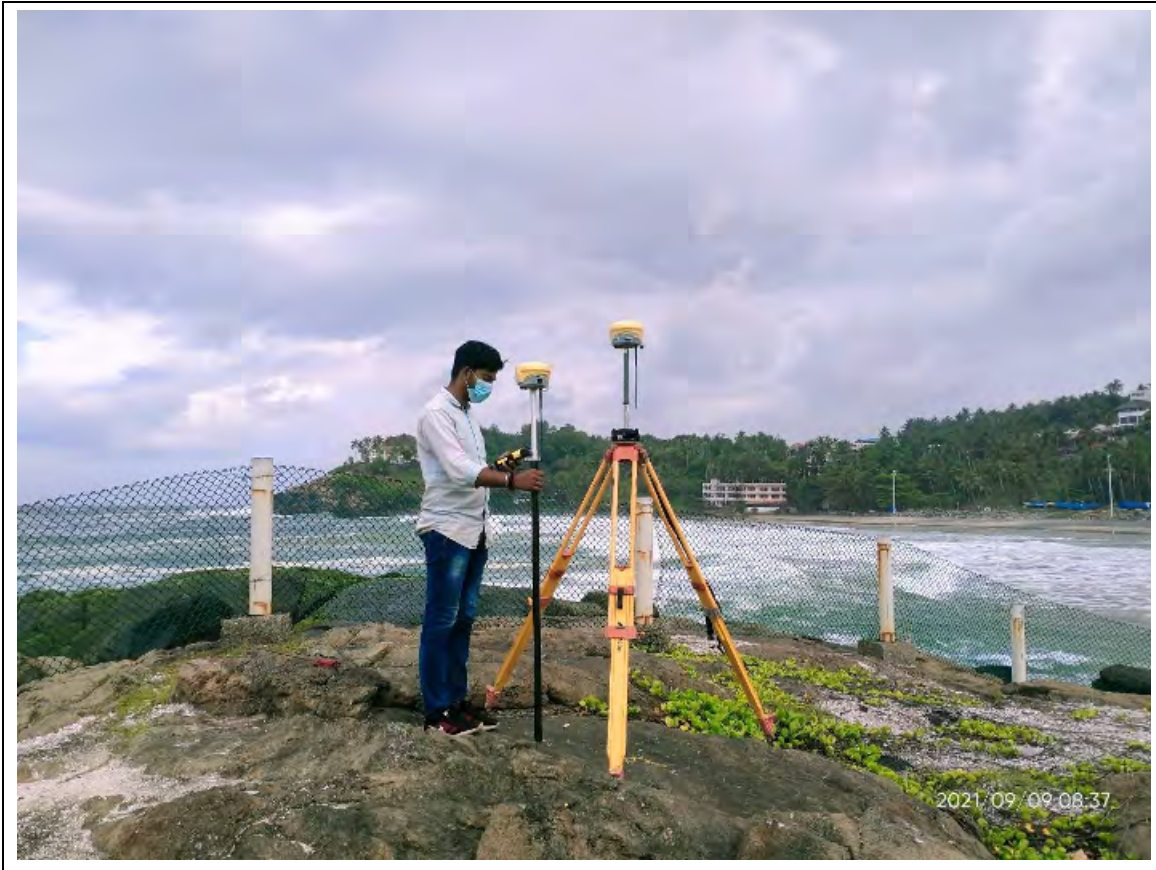
An RTK system was mobilized at site to carry out cross-shore profiling on the landward side. The system used was a Geomax Zenith 35 Pro RTK system with base station and rover. A photograph of the system is provided below:

Figure 5-6: RTK System with base station and rover

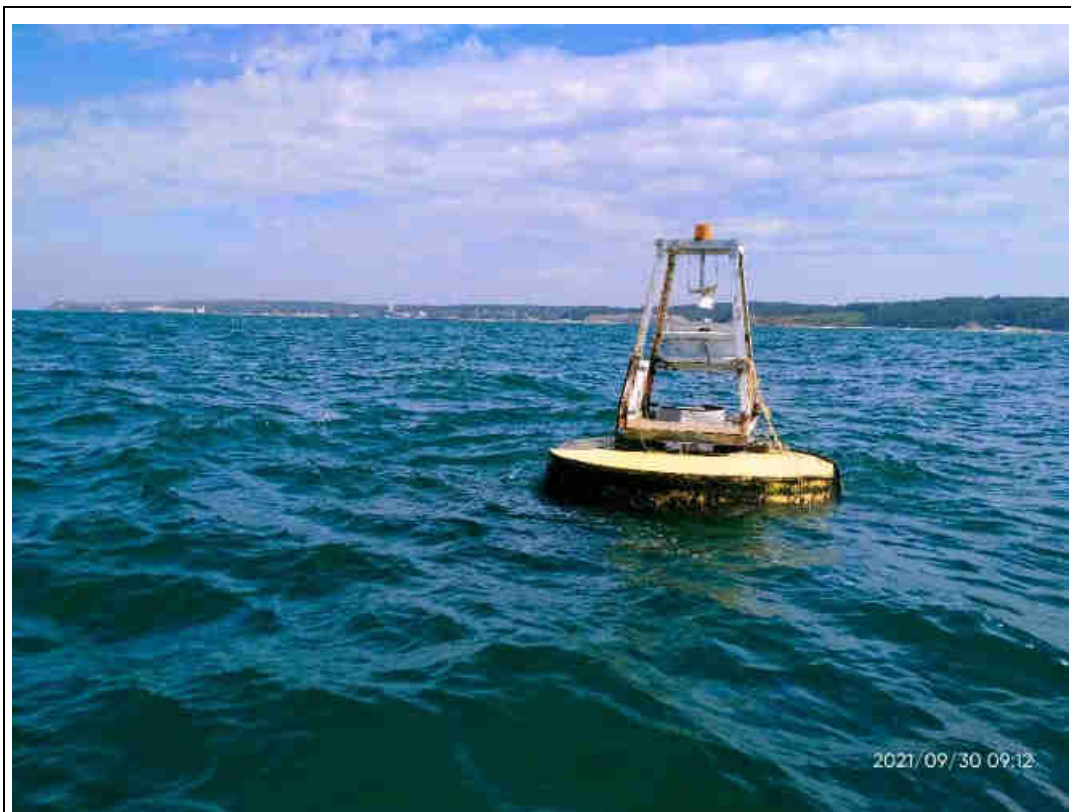
The data from the turbidity buoys was transmitted and recorded on the server at an interval of every 10 minutes. A photograph of a turbidity buoy is shown in the figure below.

Figure 5-10: Turbidity Buoy-1

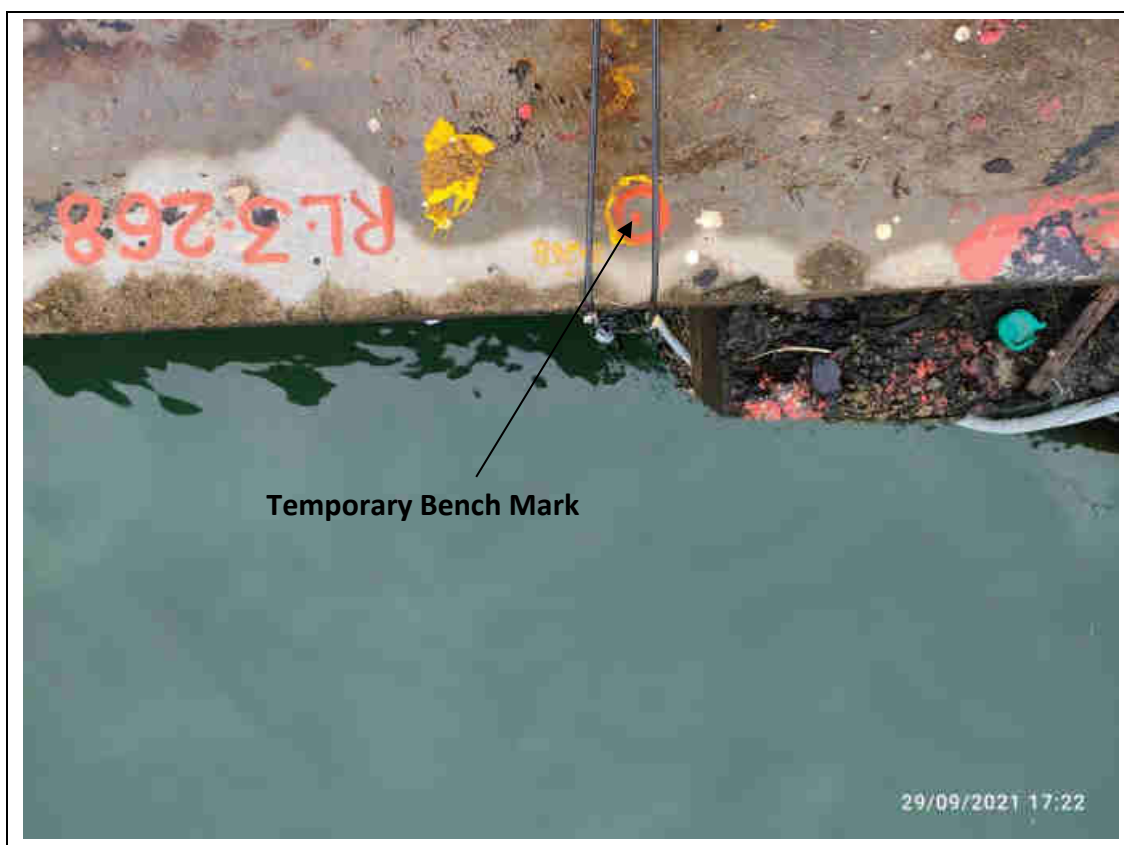
Figure 6-1: Location of TBM

The tides were observed near the Coast Guard jetty. The tide is referenced to the chart datum, the value of which was provided by VISL. The temporary benchmark (TBM) is marked on the wharf and is 3.268m above chart datum. An image of the TBM is provided below:

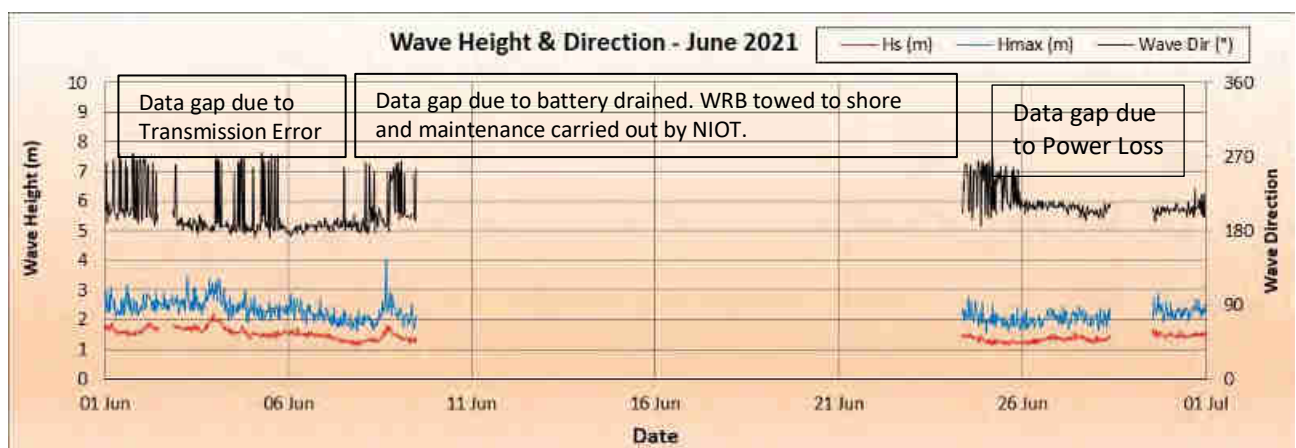
- ① The time series of wave data from April to September 2021 is shown below. The data gaps are a result of either power loss at receiving station or transmission errors. On 9th June 2021, the WRB stopped transmitting data completely due to battery drainage. It was towed to shore and redeployed on 24th June after changing the battery and maintenance.

Figure 6-5: Time series of wave parameters

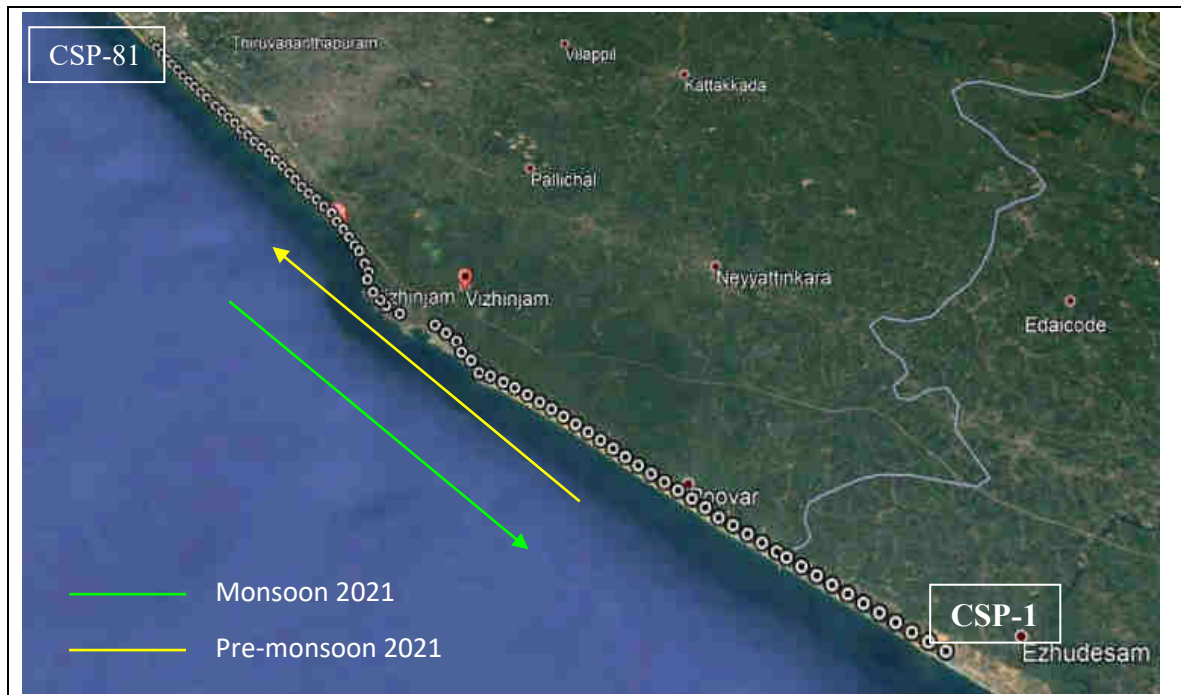
A pictorial representation of the alongshore current direction for each of the seasons, i.e. pre-monsoon and monsoon 2021 is shown in the Google Earth image below.

Figure 6-16: Representation of surface current directions in different seasons

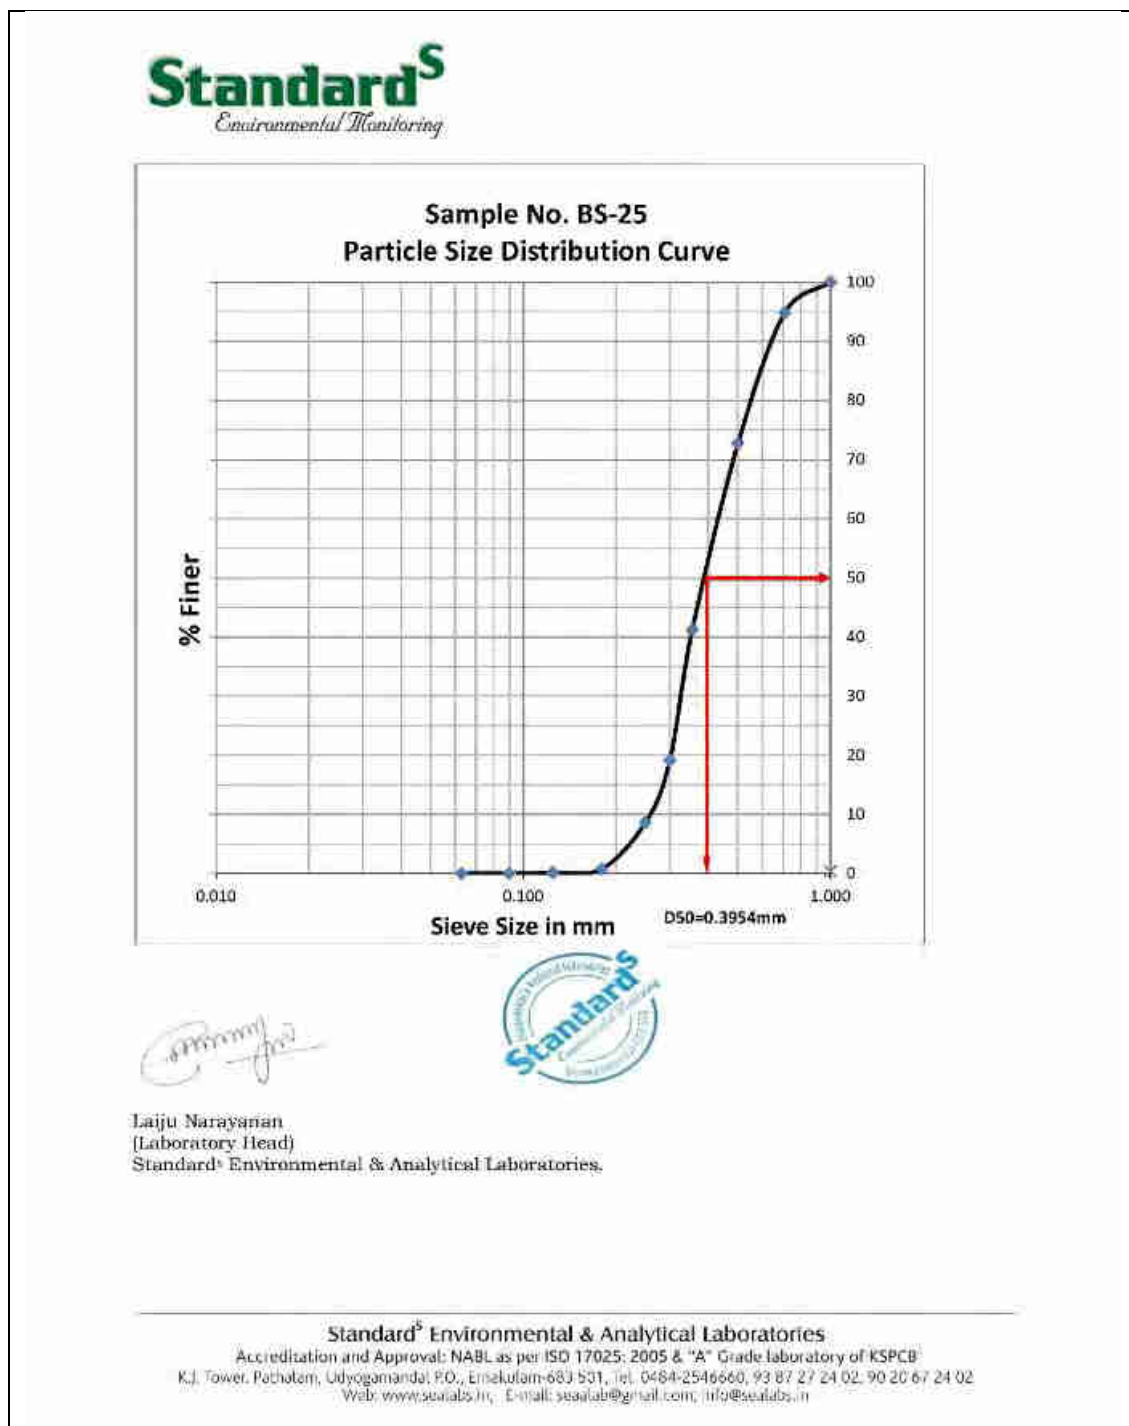
Figure 6-28: Grain size distribution curve for BS-25 (Monsoon)

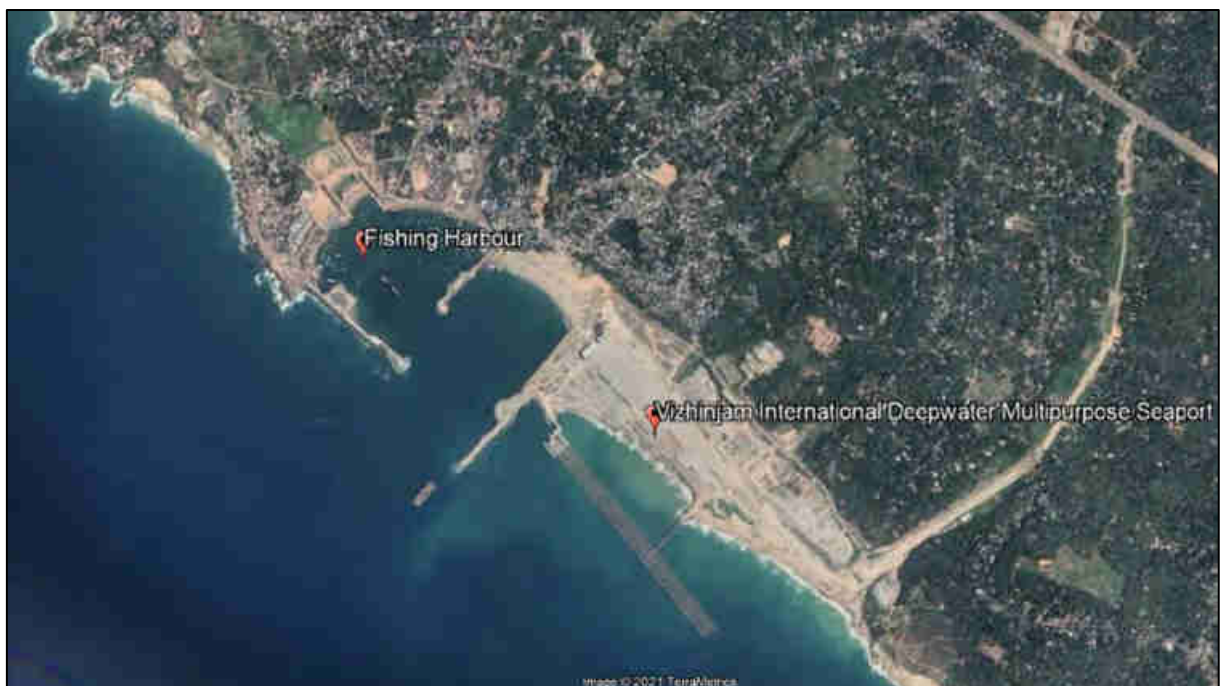
Figure 1-2 Location of the port (zoomed in)

The deep-water port is being constructed at Vizhinjam in Thiruvananthapuram District of Kerala. A Vizhinjam fishing harbour is located at about 300m north of the port and is a major landmark at this location. The port location is shown in Figure 1-2.

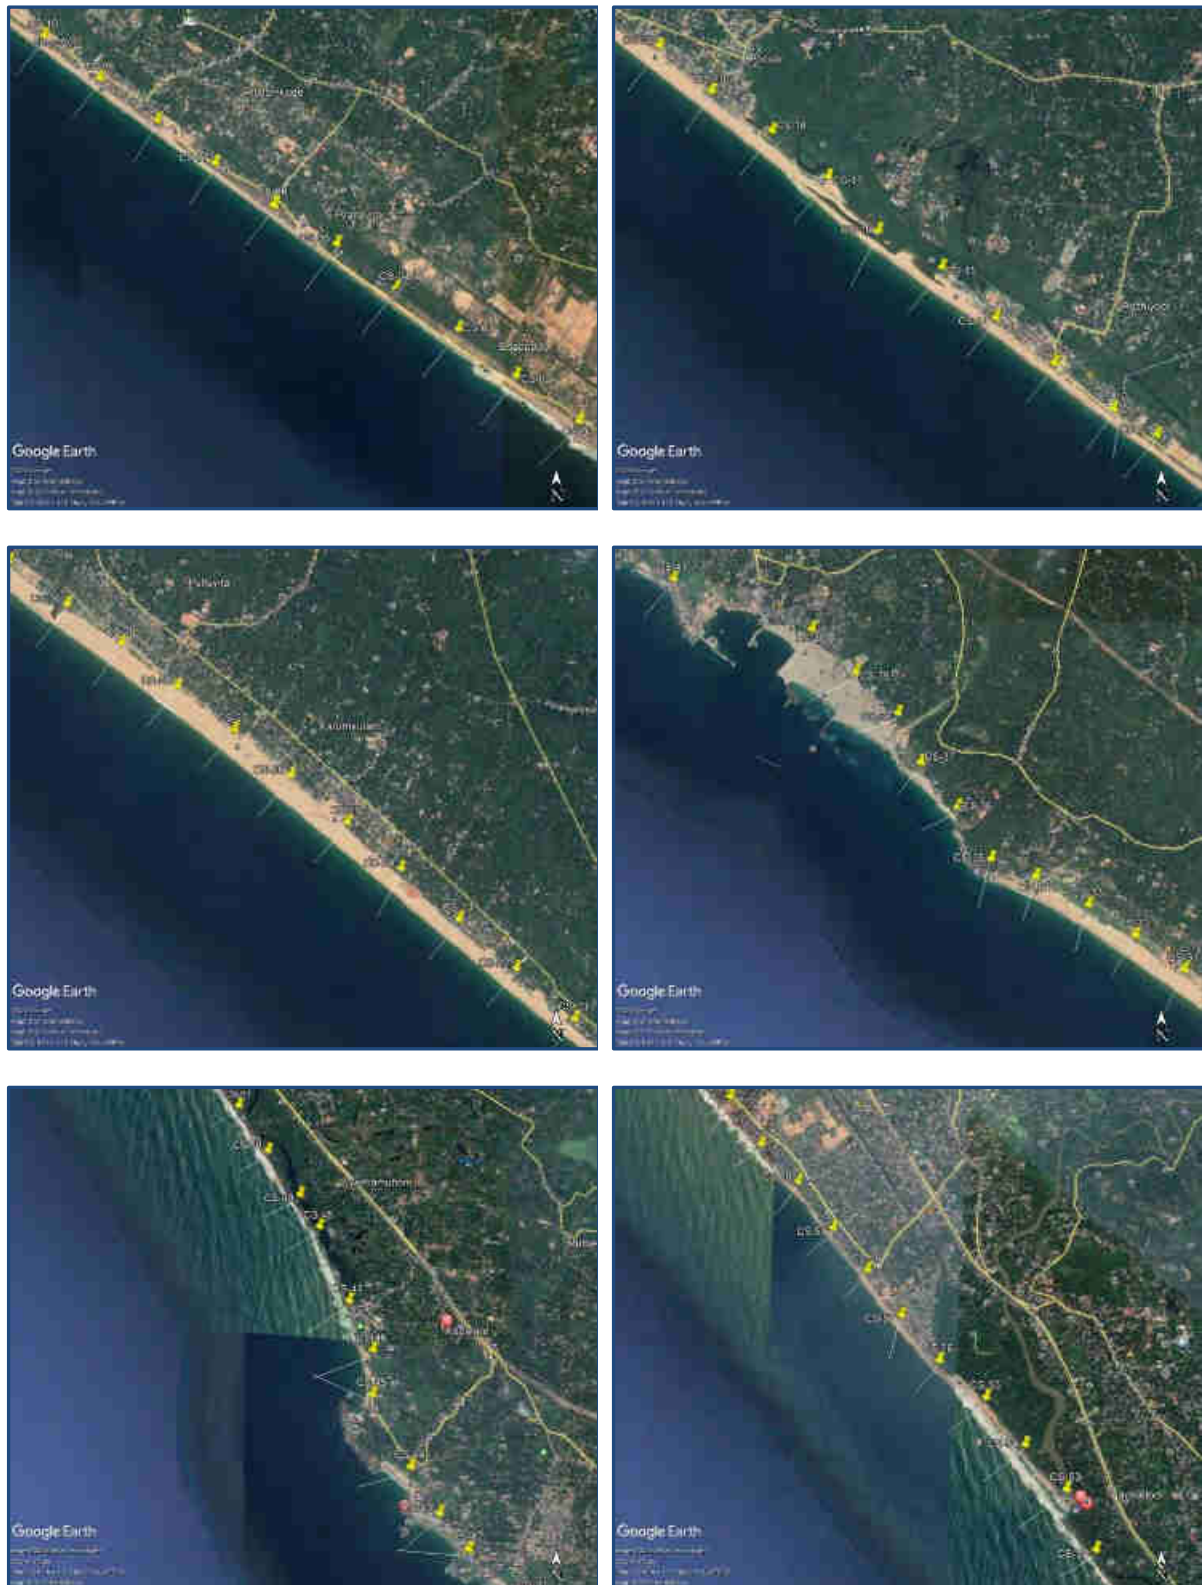
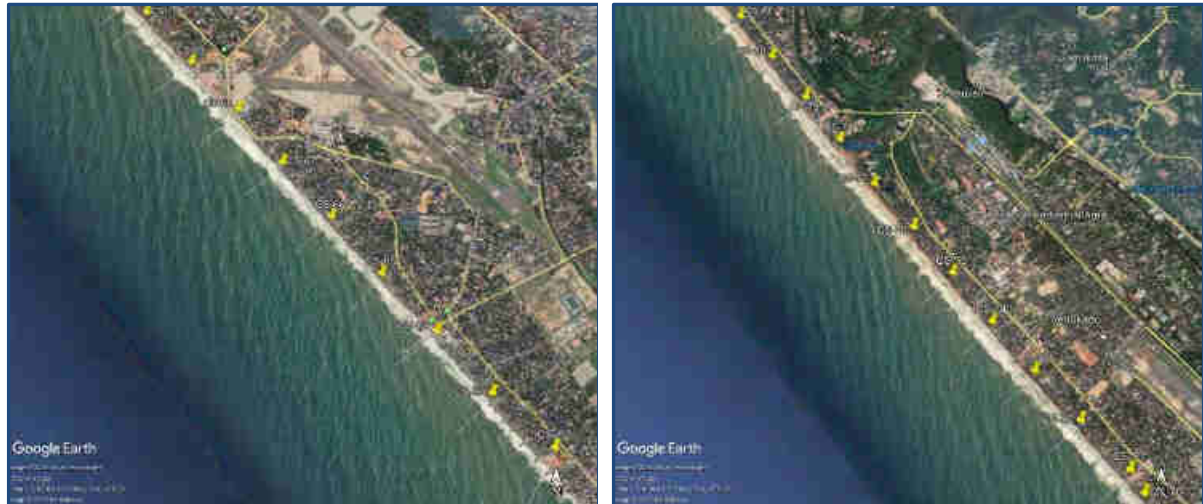
Figure 2-79 Cross Shore Profile Locations

Cross shore beach profiles were collected by AVPPL at 81 locations which cover approximately 40 km along the coastline. The spacing between two adjacent cross sections is approximately 0.5 km. Among the 81 locations, 41 are to the north of port, 37 are to the south

of port and 3 are at the port location. Survey data from February 2015 to February 2021 is available. The cross-shore profile locations are shown in Figure 2-79.
